### South Deep Channel

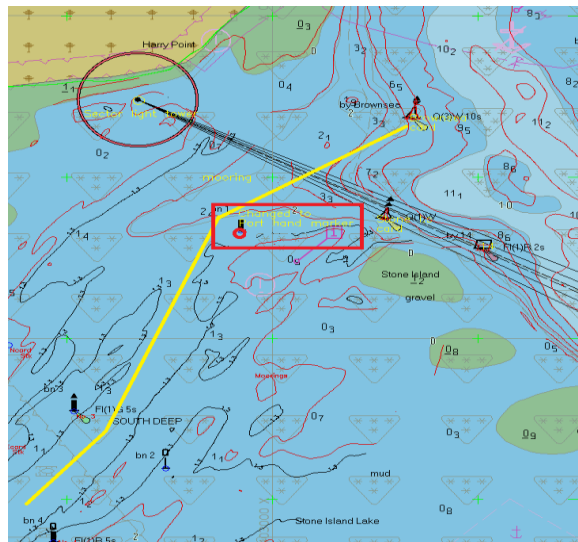
A recent survey of the South Deep Channel has shown the entrance to have shifted position. Therefore, South Deep No.1 (previously a starboard hand green beacon) has been changed to a port hand red beacon and is now unnumbered. The light characteristic has been changed to Fl.R5s. Mariners are advised to follow the beacons new colour and light characteristics and disregard Admiralty chart characteristics until a new starboard hand beacon is established and chart corrections issued.
