East Looe Cut

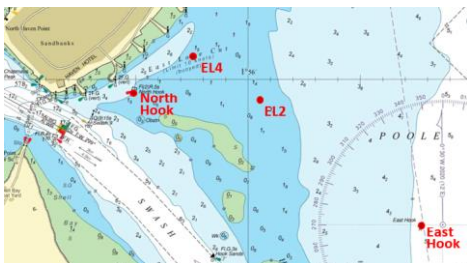
Mariners are advised that secondary harbour entrance approach from the east known as the “East Looe Cut” should only be used with caution. Mariners are advised to first calculate their underkeel clearance and consider sticking to fair weather and high water only. If current depths or vessels’ draft are in any doubt, this shortcut should be avoided and the Swash Channel used. It is marked by two port hand marks (EL2 and EL4).

Mariners should consider these buoys as marking the north and east extent of the worst of Hook Sands. **For passage planning purposes, it is safest to use a Controlling Depth of 0.7 metres below Chart Datum.** Expected under keel clearance should be calculated by taking the current Height of Tide (check [here](#)), adding 0.7 metres, subtracting current wave height and subtracting the vessel’s draft.

Annual pre-season surveys show shifting sandbars leading to an ever-decreasing reliability for this approach. Buoys positions are reviewed each spring to check they guide the approximate deepest approach but there is an inevitable delay in responding to sudden changes to depths following particularly heavy weather (which may be temporary). The area’s shallow depths, swift tidal flows and large breaking swells require buoys with heavy sinkers and long risers, meaning that sinkers can be a hazard in themselves when often found scoured proud of the seabed and some distance from the buoy. As a result, since 2018, the cut is no longer referred to as a “channel” and the buoy positions are not included on Admiralty Charts or electronic chart updates (other than North and East Hook). In 2020, the starboard hand marks were also discontinued due to a significant reduction in use by commercial vessels and an increasing concern that the paired buoys being trialled were giving a false sense of security. The two port hand marks were last relocated in Spring 2021. **Buoy EL4 is at 50°41.056’N 001°56.136’W** and **Buoy EL2 is at 50°40.949’N 001°55.871’W** (see above chartlet).

That said, a much more favourable deeper water channel can generally be found when leaving these buoys closely to port inbound and starboard outbound. Experienced mariners can request the latest detailed survey (to use at their own risk) by emailing harbourmaster@phc.co.uk.
