East Looe Cut

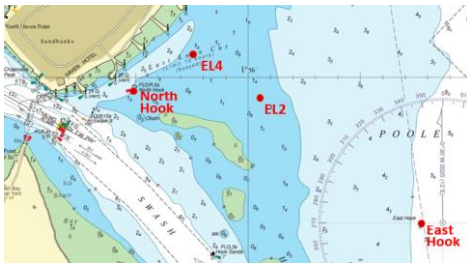
Mariners are advised that secondary harbour entrance approach from the east known as the “East Looe Cut” should only be used with caution. Mariners are advised to first calculate their underkeel clearance and consider sticking to fair weather and high water only. If current depths or vessels’ draft are in any doubt, this shortcut should be avoided and the Swash Channel used. It is marked by two port hand marks (EL2 and EL4).

Mariners should consider these buoys as marking the north and east extent of the worst of Hook Sands. **For passage planning purposes, it is safest to use a Controlling Depth of 0.7 metres below Chart Datum.** Expected under keel clearance should be calculated by taking the current Height of Tide (check [here](#)), adding 0.7 metres, subtracting current wave height and subtracting the vessel’s draft.

Annual pre-season surveys show shifting sandbars leading to an ever-decreasing reliability for this approach. Buoys positions are reviewed each spring to check they guide the approximate deepest approach but there is an inevitable delay in responding to sudden changes to depths following particularly heavy weather (which may be temporary). The area’s shallow depths, swift tidal flows and large breaking wells require buoys with heavy sinkers and long risers, meaning that sinkers can be a hazard in themselves when often found scoured proud of the seabed and some distance from the buoy. As a result, since 2018, the cut is no longer referred to as a “channel” and the buoy positions are not included on Admiralty Charts or electronic chart updates (other than North and East Hook). In 2020, the starboard hand marks were also discontinued due to a significant reduction in use by commercial vessels and an increasing concern that the paired buoys being trialled were giving a false sense of security. The two port hand marks were last relocated in Spring 2021. **Buoy EL4 is at 50°41.056’N 001°56.136’W and Buoy EL2 is at 50°40.949’N 001°55.871’W** (see above chartlet).

That said, a much more favourable deeper water channel can generally be found when leaving these buoys closely to port inbound and starboard outbound. Experienced mariners can request the latest detailed survey (to use at their own risk) by emailing harbourmaster@phc.co.uk.
